PROBLEMS OF LANDSCAPE ARCHITECTURE
IN
THE NATIONAL FORESTS

REPORT TO U. S. FORESTER'S OFFICE
ON
TRIP OF INSPECTION THROUGH SOME OF THE NATIONAL FOREST AREAS
IN
REGIONS 2, 4, 6 AND 1

BY
A. D. TAYLOR
CONSULTING LANDSCAPE ARCHITECT
SEPTEMBER 1935

(July 26, 1935 through August 22, 1935)

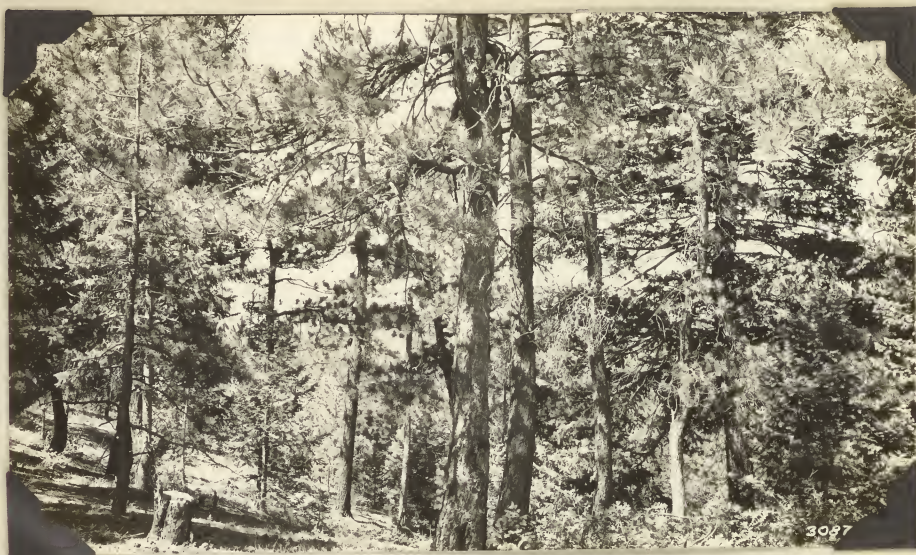
Pike National Forest - Devil's Head Road

View showing the existing pine trees (approximately six in number) which almost completely obstruct an otherwise fine scenic view across the canyon to distant ranges. The entire seven or eight-mile stretch of this road present many opportunities to produce vistas and views of great scenic value.

I strongly recommend that the proposed location of this road be checked thoroughly by the landscape architect in charge of the landscape work in this region, and that a competent landscape foreman be left upon this work during the construction program, in order to superintend the details of planning and construction as indicated in the foregoing tabulation.

This road presents one of the most outstanding opportunities which I have observed in any of the forest areas, to make a highway which has real scenic value. At the present time it is little more than a traffic way, leading from the main highway to the Devil's Head camp ground.

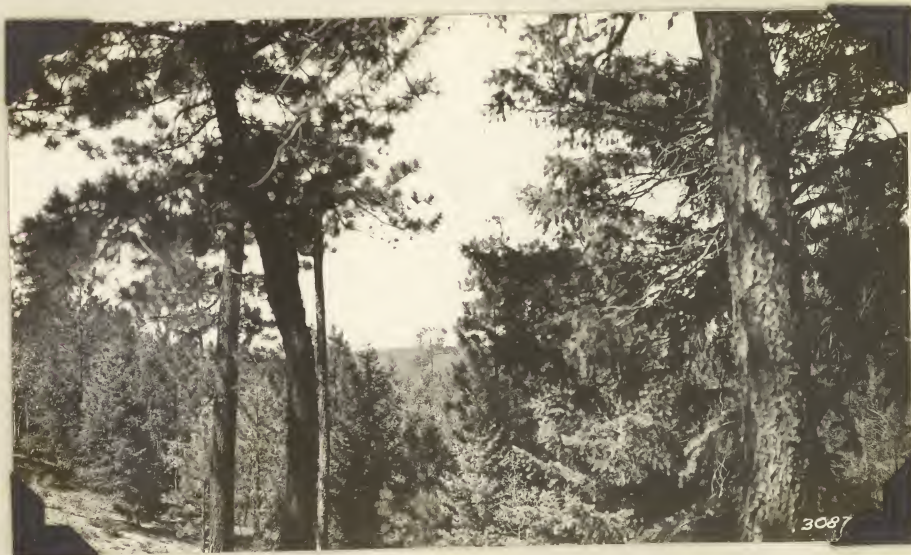
Pike National Forest - Devil's Head Road

View showing, through a small opening the possible vista to be developed by the removal of additional trees and looking across the canyon in the direction of the distant ranges.

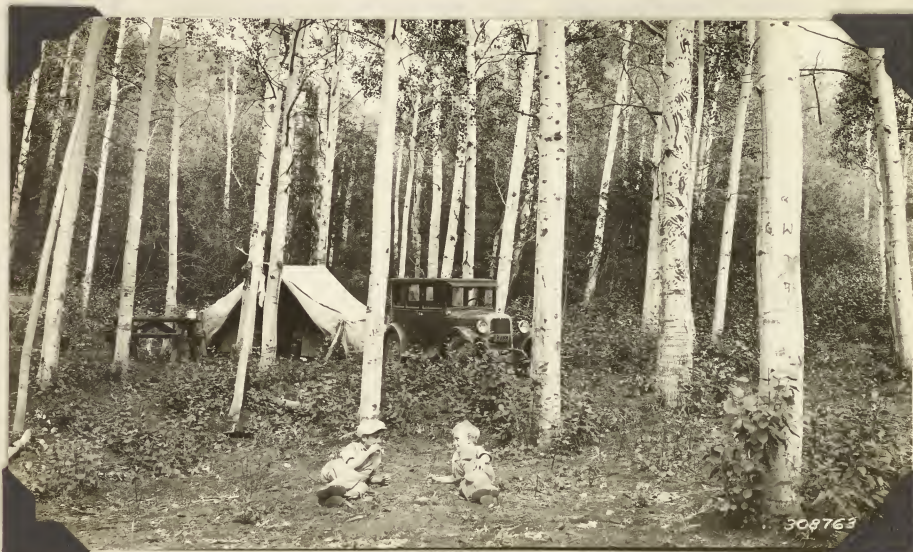
Grand Mesa National Forest - Steamboat Rock Forest Camp and Picnic Area

View among the aspen trees, showing the natural vegetation which has not yet been destroyed; but is in danger of being destroyed by the indiscriminate use of this area by automobiles, for the proper parking of which adequate arrangements are now being made.

The forest cover in this camp ground is being unnecessarily worn out by automobiles that drive indiscriminately over the area wherever there is space for an automobile to go. These automobiles should be confined in this camp ground (as in other camp grounds in this Region) to a definite parking area.

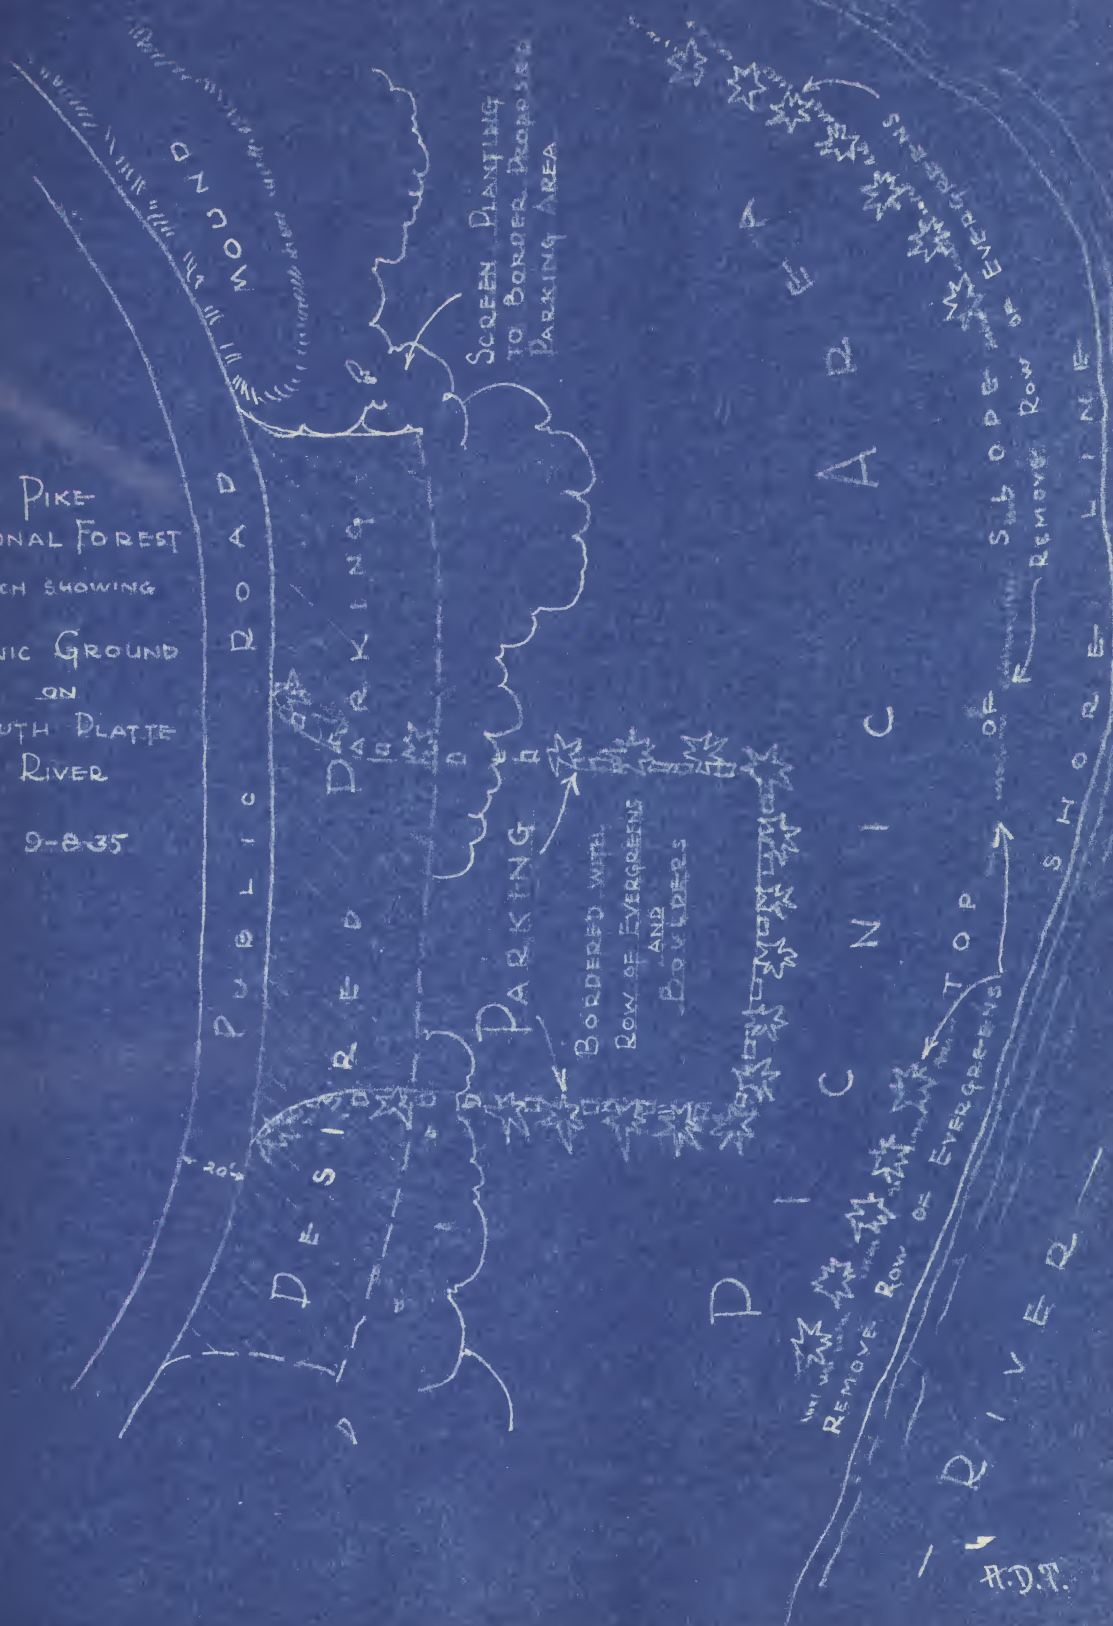
PIKE
NATIONAL FOREST
SKETCH SHOWING
PICNIC GROUND
ON
SOUTH PLATTE
RIVER
9-8-35

The planting in connection with this picnic area has not been carefully studied. At the present time there is a row of evergreens around the existing parking area, and another row of evergreens along the top of the slope. When these evergreens along the top of the slope develop, they will make a complete barrier of foliage between the picnic area and the river; a condition opposite to that which should normally exist if the picnic area is to have a proper relationship to the river.

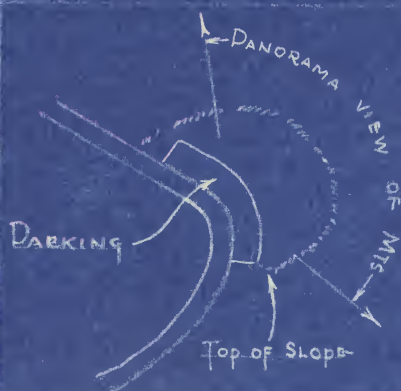
PANORAMA POINT

RELOCATE PORTION

THE CUTTING FOR TELEPHONE LINE IS UNFORTUNATE, (GOES TO LOOKOUT STATION ON SQUARE MT.)

STUDY POSSIBILITIES FOR DEVELOPMENT OF THIS POINT

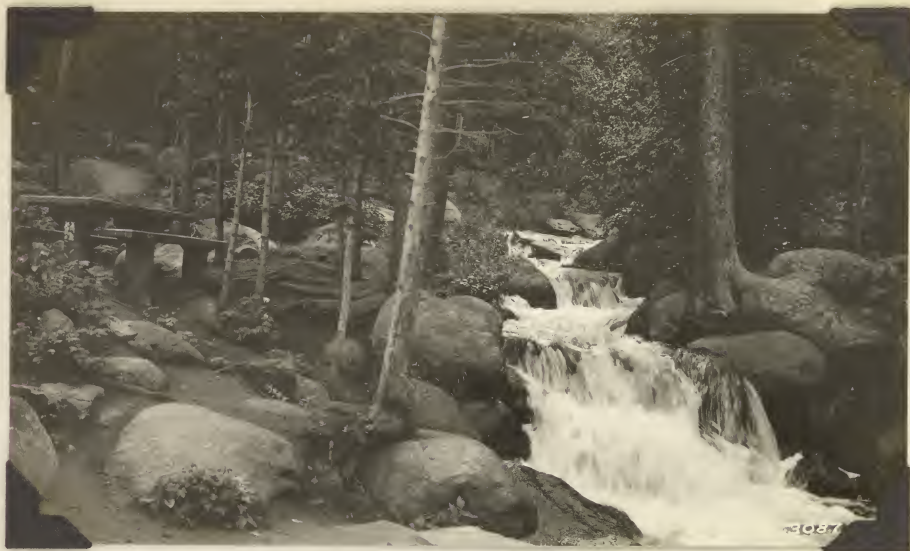
Pike National Forest - Chicago Creek Highway Approach to Echo Lake

This view shows a mountain stream where it approaches the highway and flows under the bridge. Note the interesting picnic table arrangement in the area adjacent to this stream.

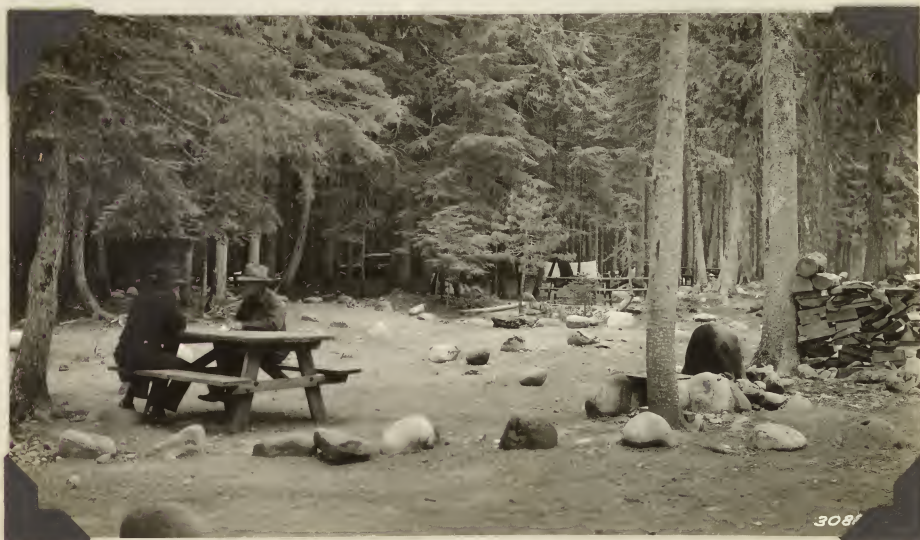
Ranier National Park - Forest Camp

General view of a camp ground unit, showing the table, stove and the stones which define the areas to be used for parking of automobiles. This effect is not natural or attractive.

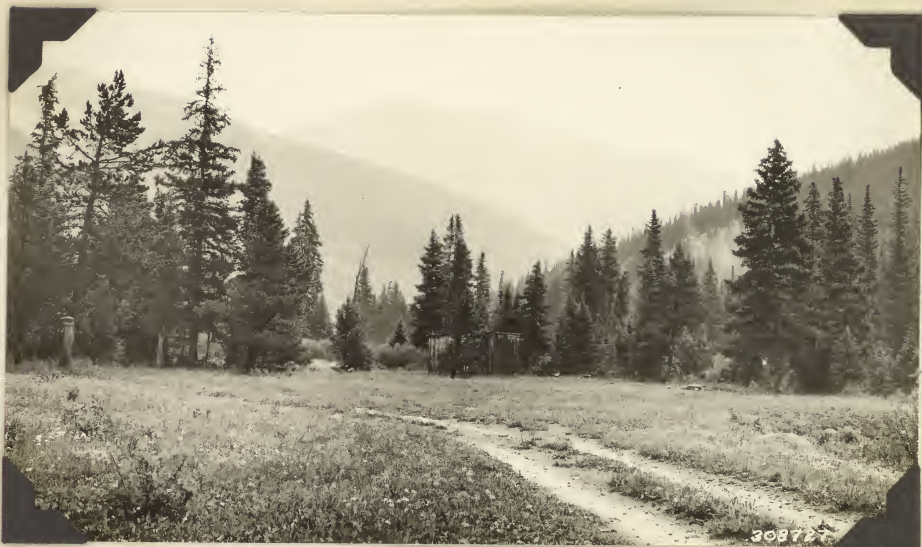
Pike National Forest - Proposed Forest Camp Site near Loveland Pass

This view shows a proposed camp ground site, located between the highway (40 S) and the creek, excellently adapted for camp use because of the mountain views, the vegetation and the proximity to the mountain stream.

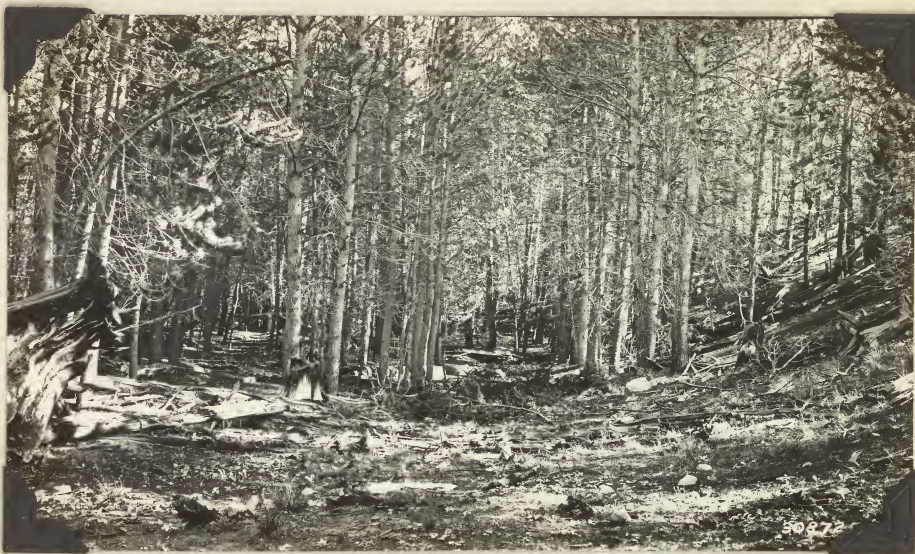
Cochetopa National Forest - Half Moon Forest Camp on Half Moon Creek

View showing the natural forest vegetation which has not yet been disturbed by any excessive use of this picnic and camp ground area. Note the number of fallen and dead trees, many of which are to be removed in order to make this area more suitable for camp ground use.

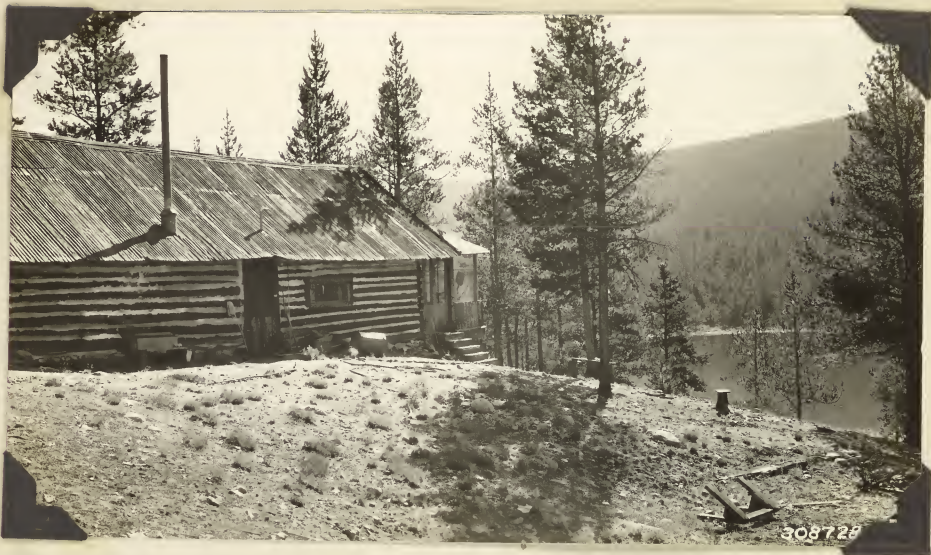
Cochetopa National Forest - Special Use Camp Area, near Half Moon Forest Camp

View showing one of the older types of private camp, designed and constructed in approximately 1920. Note the corrugated iron roof which should not be used in any modern camp. Also note the artificially developed lake in the background.

This camp site could be very greatly improved by the introduction of a few native plants around the foundation of this building and other buildings in this area. The corrugated roof should not be tolerated in any of the private camps.

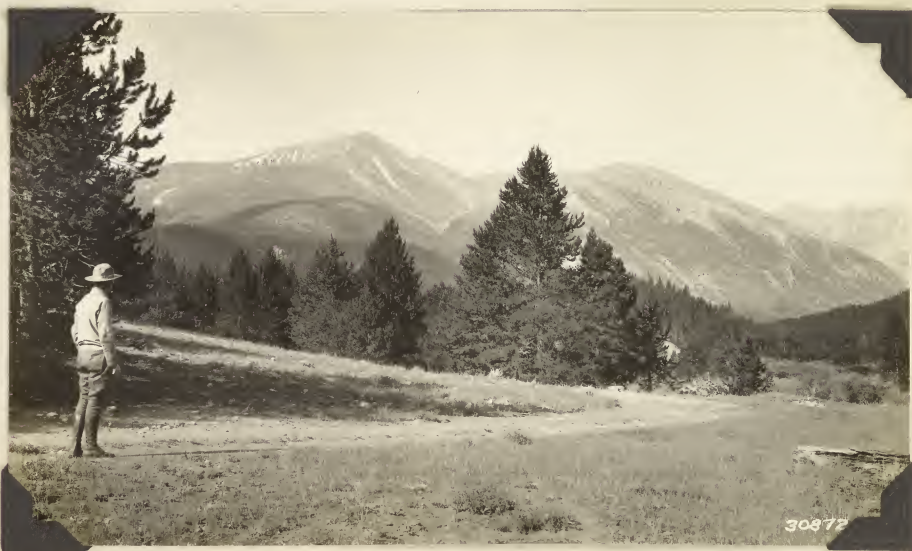
Pike National Forest
Proposed Forest Camp Site near Loveland Pass

This view shows a proposed camp ground site located between the highway (40 S) and the lake, excellently adapted for camp use because of the mountain views, the vegetation and proximity to the mountain streams.

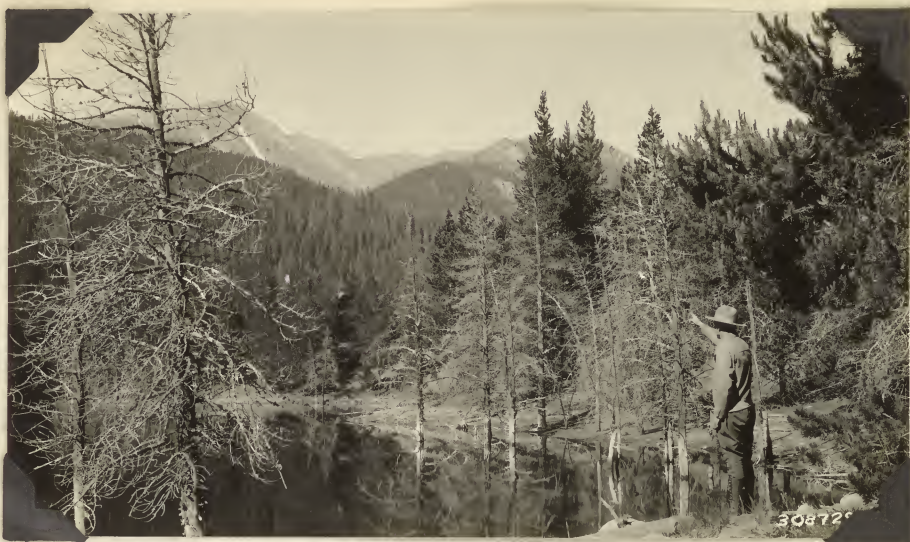
Cochetopa National Forest
Artificially Created Lake near Half Moon Forest Camp

Photograph No. 308729, (page 42.) shows the damage which develops as a result of raising a water level. It is important that these dead trees should be removed at an early date in order to restore the natural forest atmosphere.

View showing the condition which develops when the water in an existing lake is raised. These dead trees should be removed.

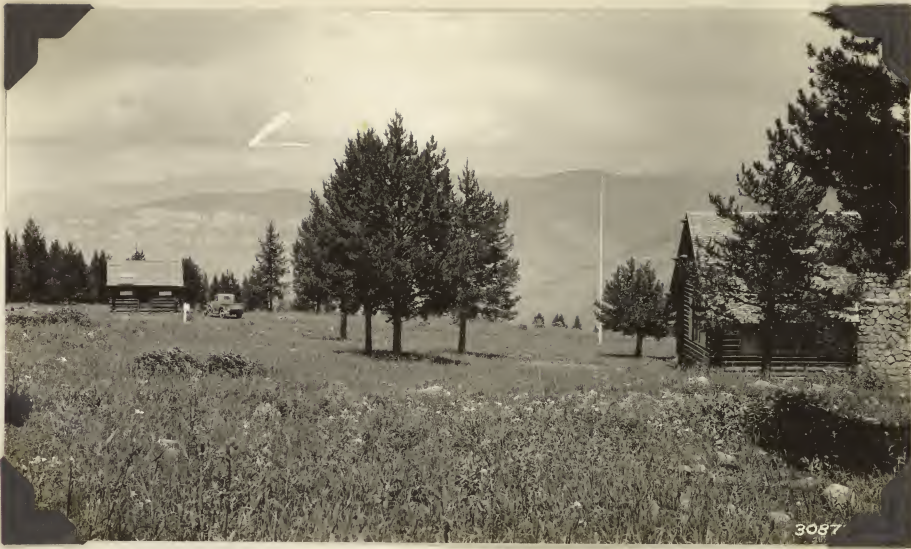
Holy Cross National Forest - Tigiwon Forest Camp

General view from a point above the existing recreation building, and looking over a portion of this camp ground, across the valley, and toward the Gore Mountain Range in the extreme distance.

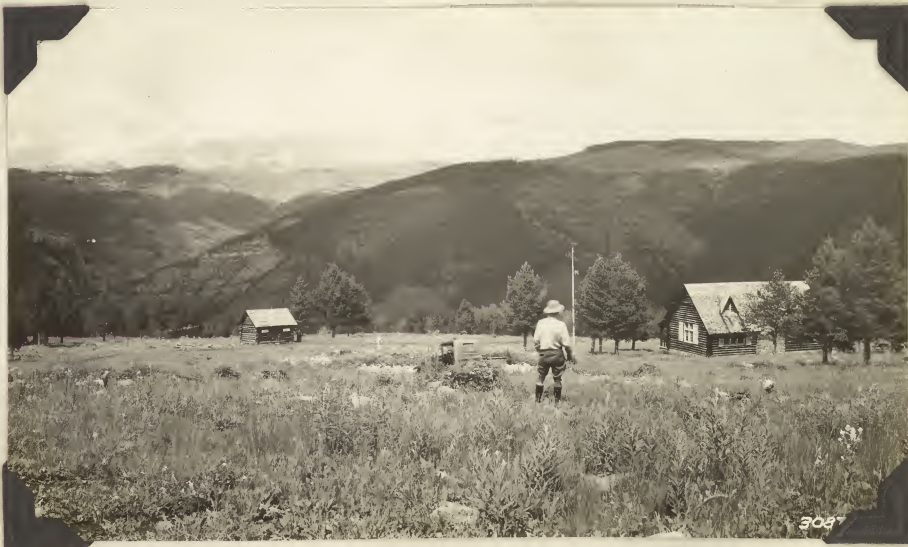
Holy Cross National Forest - Tigiwon Forest Camp

View from the upper portion of the camp ground, looking over the camp ground toward the distant mountains across the Eagle River Valley. The new proposed dining hall should be located approximately where the Forest Ranger is standing.

- A. Location of additional buildings.
 - 1. Dining hall.
 - 2. Administration building.
- B. Relocation of a portion of the existing road south of the present recreation building in order to provide a better use of this particular area.
- C. Location of a suitable camp site, preferably on the east side of this area at the edge of the forest.
- D. Development of adequate community parking space for those using this camp ground and picnic area.
- E. Individual camp and picnic units. (With provision for tent, fireplace and table.)
- F. Development of spring as a source of water supply.
- G. Problems of thinning existing growth and planting native materials in connection with existing and proposed buildings and other features.

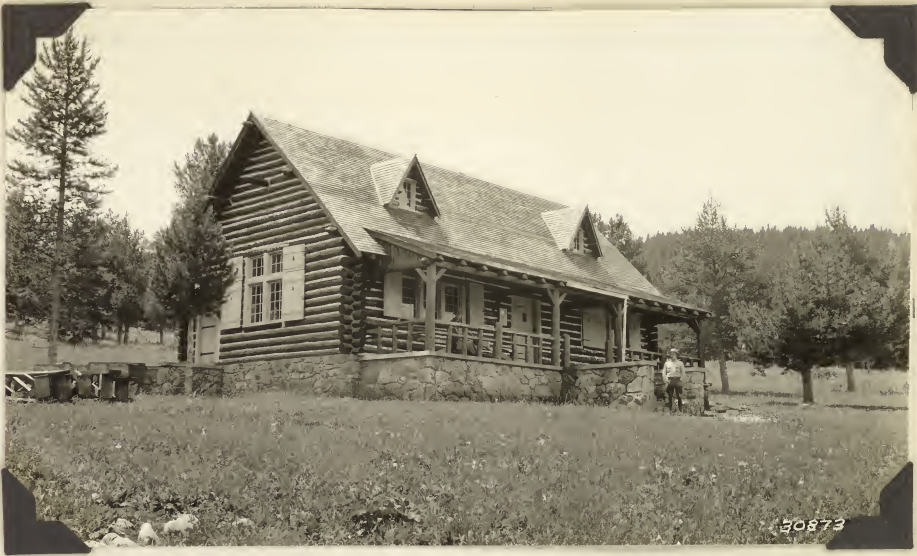
Holy Cross National Forest - Tigiwon Forest Camp

A most interesting type of recently designed and constructed recreational building for the general use of Tigiwon Camp. The floor grade of this building should have been lowered at least two feet and some native plant material should be planted around the base of the building to give it a more natural setting. The "pretentious" treatment of the front entrance steps detracts greatly from the quiet simplicity of the design of this building. This step feature should be completely redesigned to be less "obstrusive".

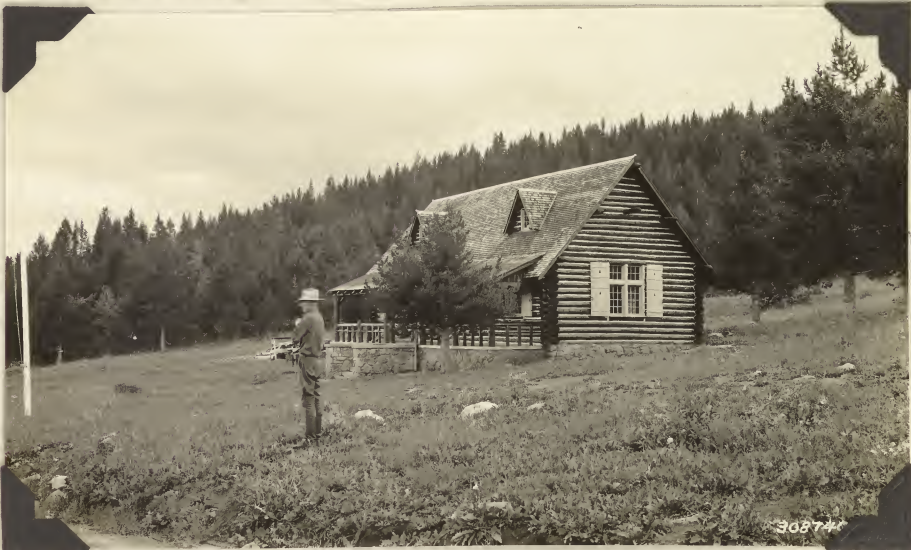
Holy Cross National Forest - Tigiwon Forest Camp

General view showing the front of the recreation building in this camp ground. This view of the recreation building shows very clearly the necessity for development of adequate plantings both of native shrubs and of specimen trees to enframe this structure and to give a more natural forest setting.

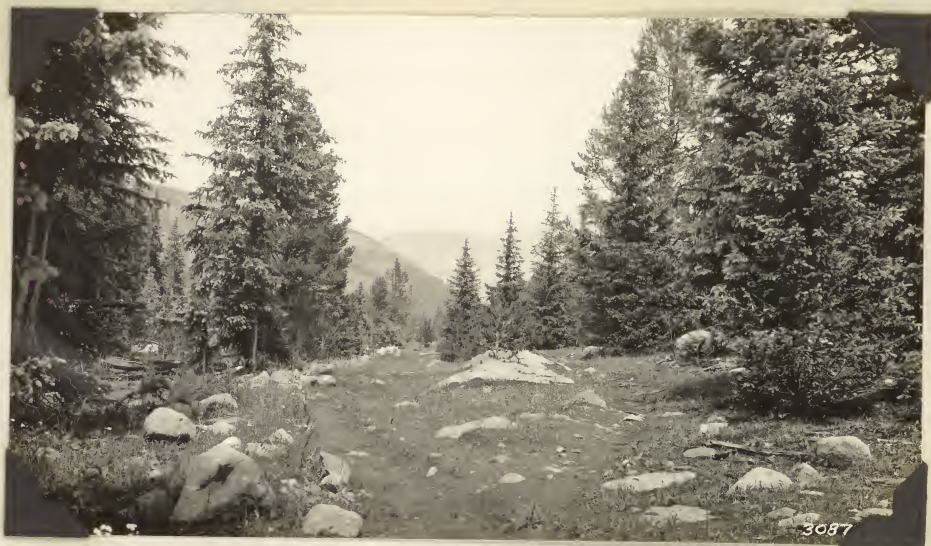
Holy Cross National Forest

The combination bridle trail and foot trail, shown in photograph No. 308738 (page 51), is of a width sufficient to accommodate only one person. I think that trails of this kind ought to be at least $3\frac{1}{2}$ to 4 feet in width in order to accommodate two persons abreast.

"Upper" Camp Ground, approximately two miles above Tigiwon Forest Camp. A narrow horse trail and foot trail combined, which leads from this upper camp ground toward the top of Holy Cross Mountain and the "Notch". From my observation of the use of these trails in different forest areas, I feel that such a trail should be 4 feet in width.

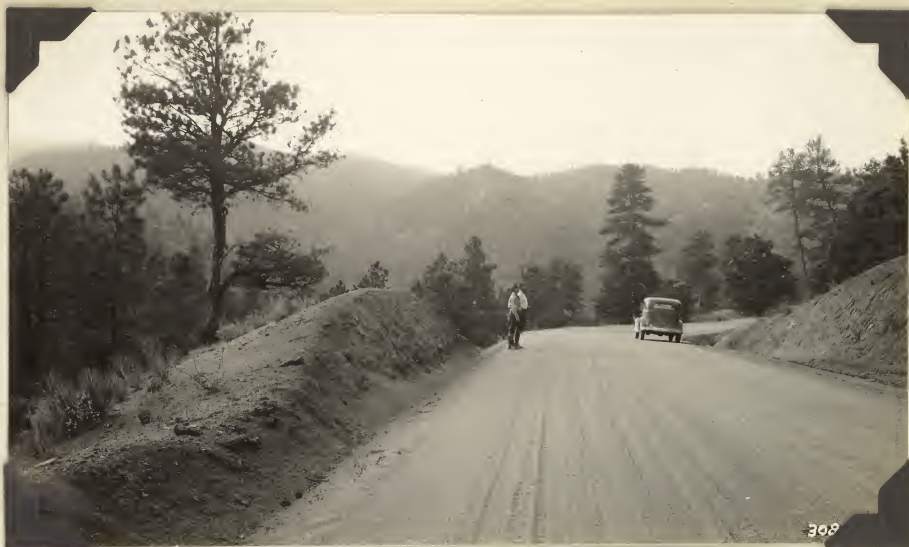
Pike National Forest - Deckers-Buffalo Road

View of existing conditions on the recently constructed Deckers-Buffalo Road where a number of similar mounds have been left along the down slope side of the highway. These mounts could easily have been removed with very little additional expense at the time when the original subgrading of the road was being completed. They are unsightly, they detract from the natural effect of the highway, and in many cases (as in this instance) obstruct some portions of the distant view.

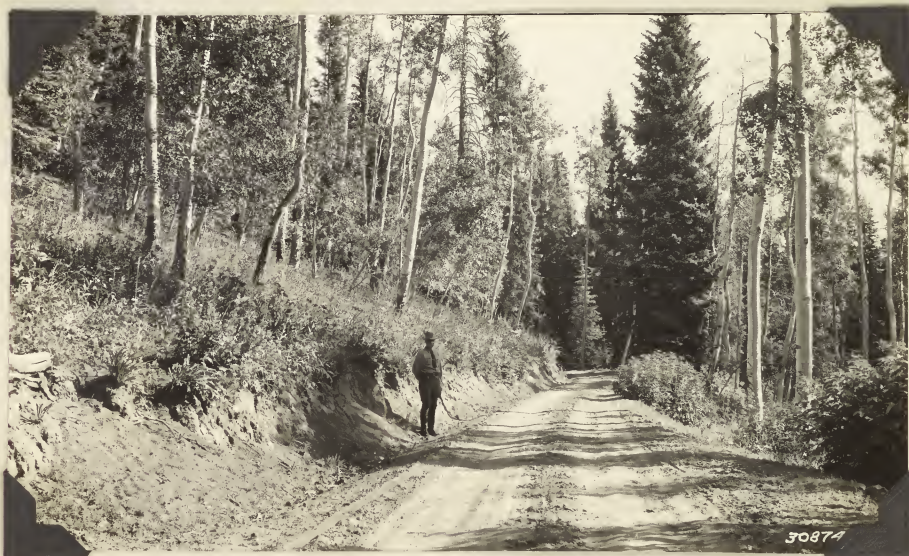
White River National Forest - New Castle-Buford Road

Detail view along the forest highway, showing a bank which should be regraded, and also showing a woodland slope covered with arnica.

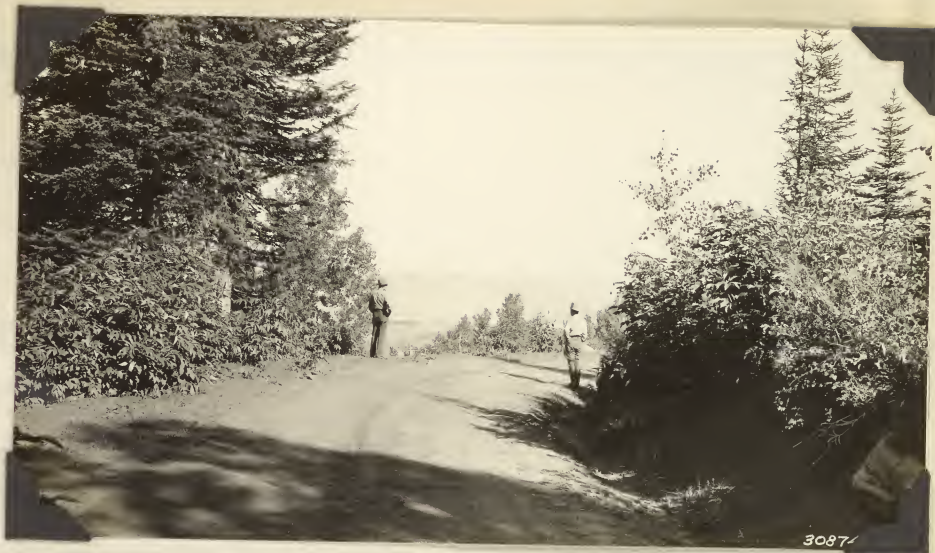
White River National Forest - New Castle-Buford Road

One of the typical scenic views across the White River Valley toward the distant mountain ranges. Adequate width of roadway should be provided in such locations, to give opportunity for automobiles to stop at these scenic points.

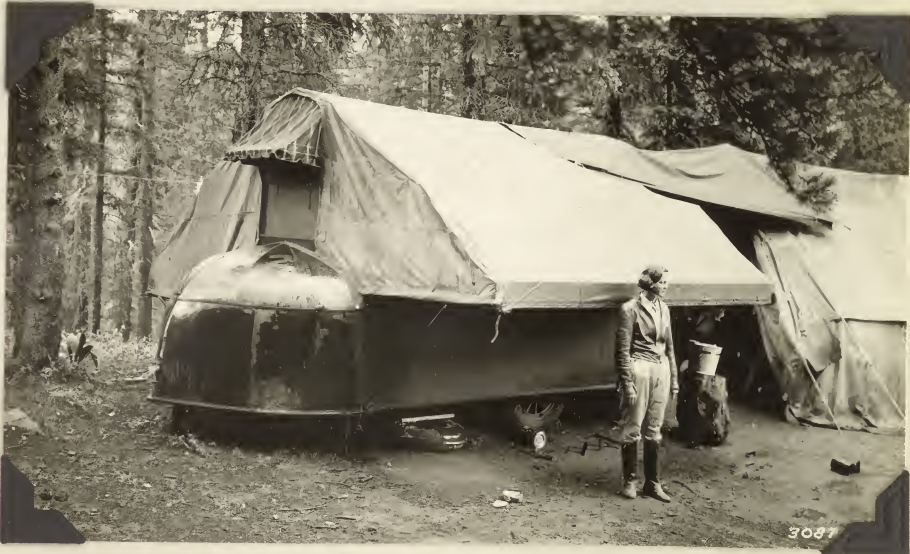
White River National Forest - Trapper's Lake Forest Camp

This photograph shows an interesting type of trailer, provisions for the use of which must be made in the camp grounds. The best solution for this problem seems to be that of providing a small "loop" which gives opportunity for parking these trailers. They should not be permitted the same use of the camp ground roads as is permitted to automobiles. This trailer was made by Mr. John R. Burrows, Colorado Springs, Colo., in 1923.

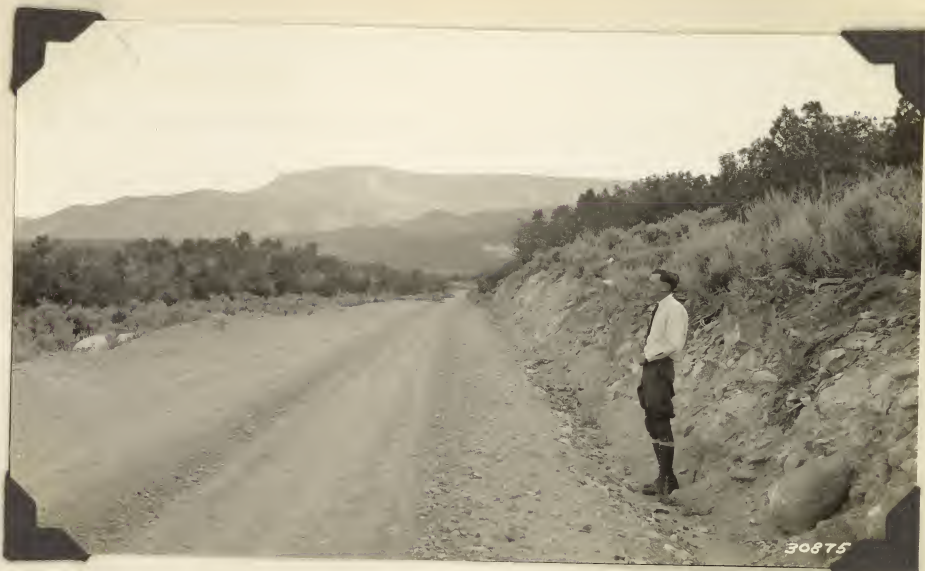
Grand Mesa National Forest - Land's End Road

A view looking along Land's End Road, just above the valley, toward the Grand Mesa Plateau in the extreme background. Note the necessity for grading the slopes along the sides of the road so that the natural cover will readily re-establish itself.

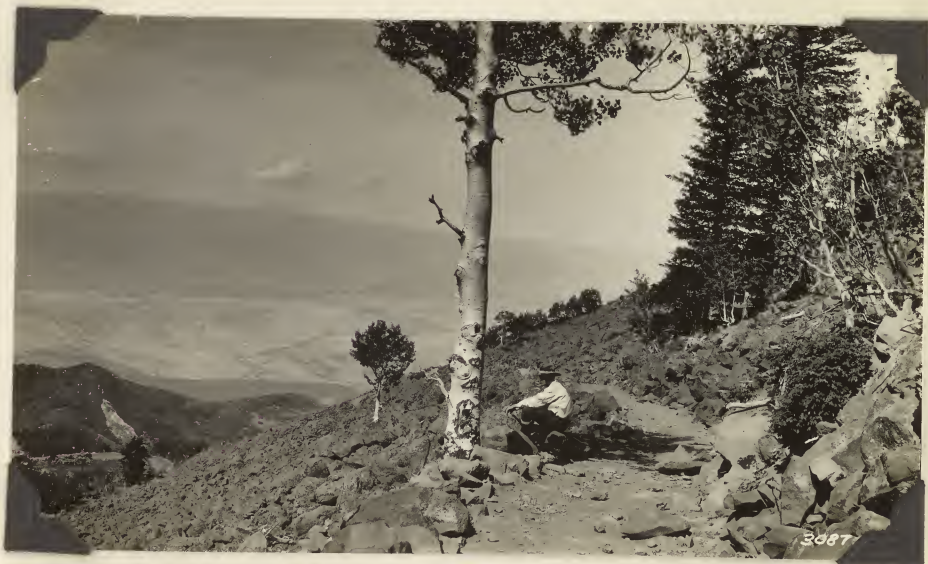
Grand Mesa National Forest

A view looking along the old trail which leads to the rim of the Plateau. This trail ought to be preserved after the new road is completed. It is a valuable feature for those persons who desire to hike to the Plateau from the camp ground below.

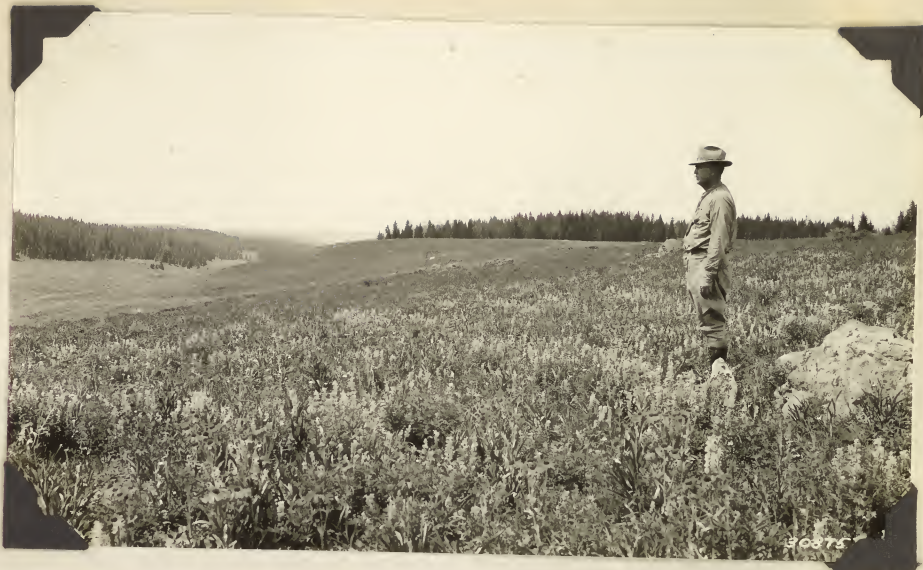
Grand Mesa National Forest - On Grand Mesa Plateau

Typical view on the Grand Mesa Plateau. Any roads constructed on this Plateau should be so located that they will take full advantage of the existing topographic features and will provide access to the many points of unusual interest on this Plateau. The photograph shows the area covered with lupine and sneezeweed.

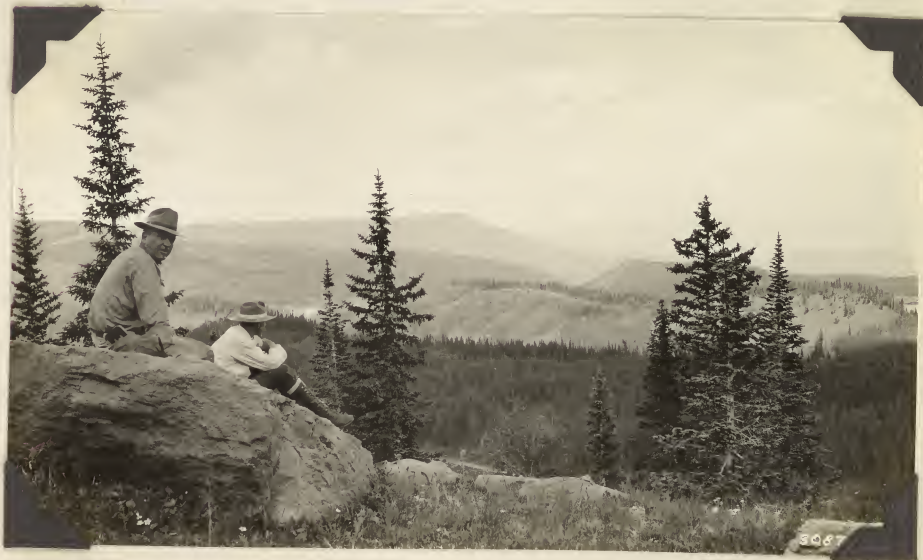
Grand Mesa National Forest - North Rim

View of the Grand Mesa Plateau across the mountain ranges. The road being developed on this plateau (approximately 58 square miles in area) ought to touch the rim of the plateau at points where these outstanding scenic views may be procured.

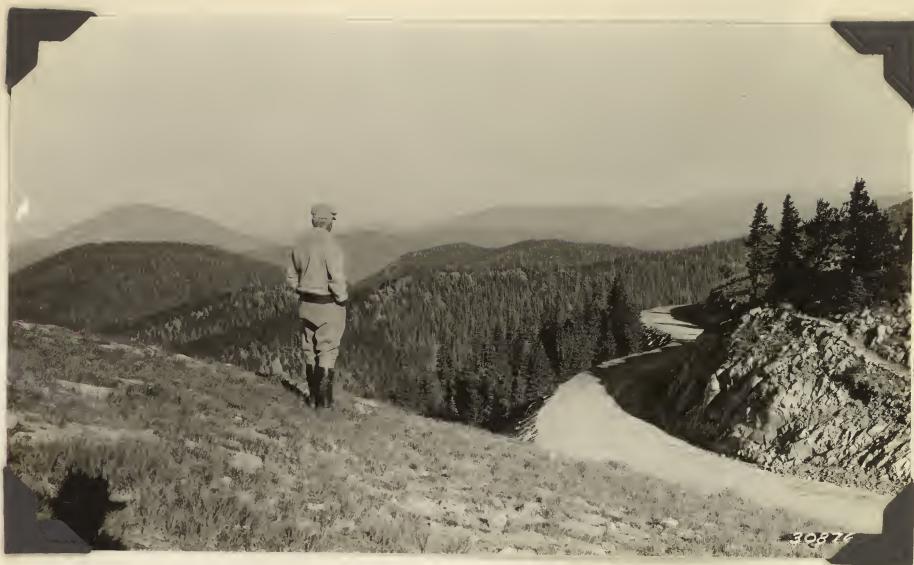
This pass provides some marvelous views across the mountain ranges (see photograph No. 308764, page 61), and it seems to me that in this location, as in other locations, on the "divide", some sort of shelter facilities should be provided for those who might wish to stop and enjoy the scenery.

View taken from the top of Monarch Pass showing ranges of mountains lying in the distance (looking toward the west). It seems very desirable in locations of this character to provide some sort of adequate and appropriate shelter for those who desire to stop and enjoy these wonderful views.

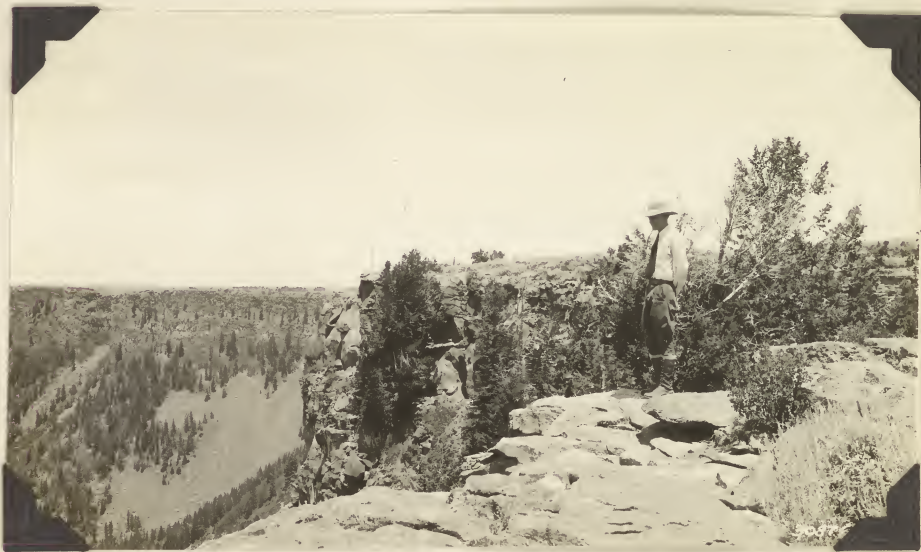
Grand Mesa National Forest - South Rim

View from a point near the South Rim where an overlook shelter should be constructed to provide facilities for those persons who come to the plateau, in which they may be protected against bad weather and enjoy the view.

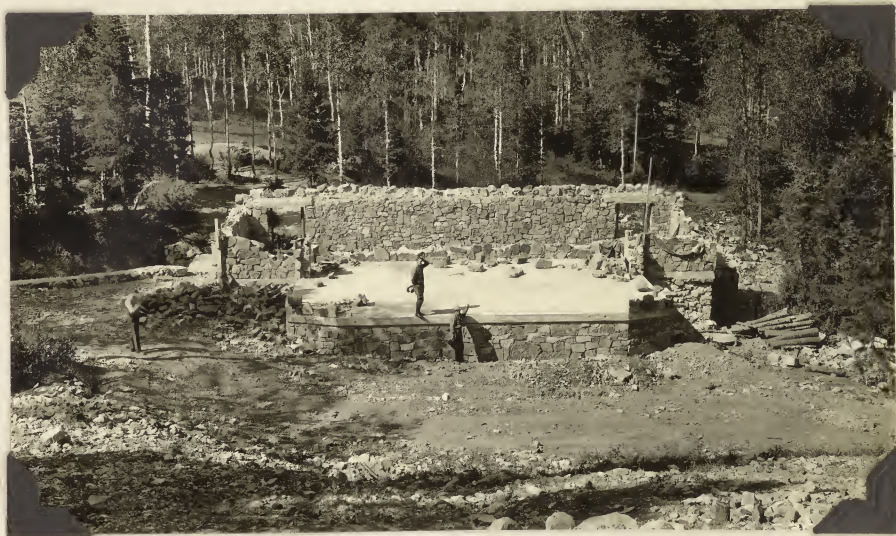
Wasatch National Forest - Aspen Grove Picnic Area

General view of the stage for the proposed outdoor theatre now being constructed in this camp ground and picnic area. Such features in the forest area require considerable planting of native trees, shrubs and vines to frame properly the architectural features.

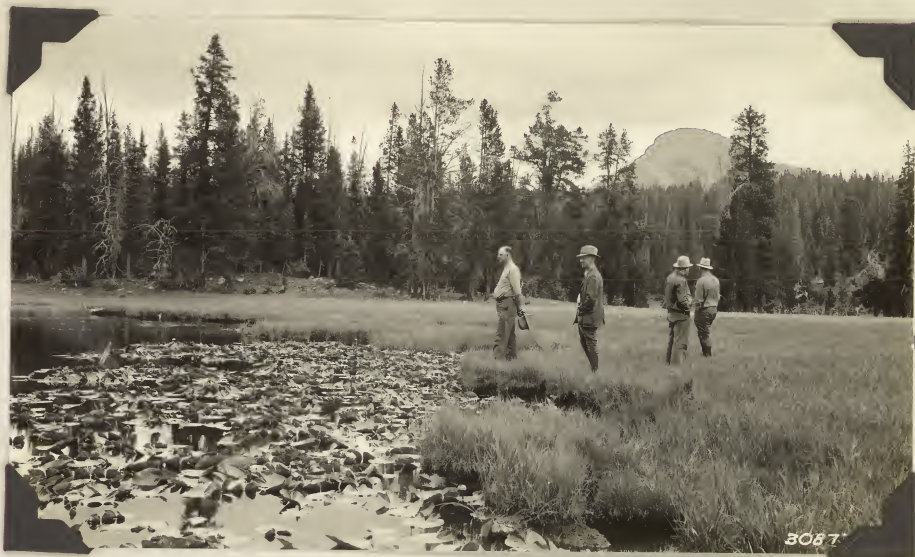
Uinta National Forest - Lily Lake

Detail view, looking across the edge of Lily Lake, with Bald Mountain in the extreme background. Note the lilies in the foreground.

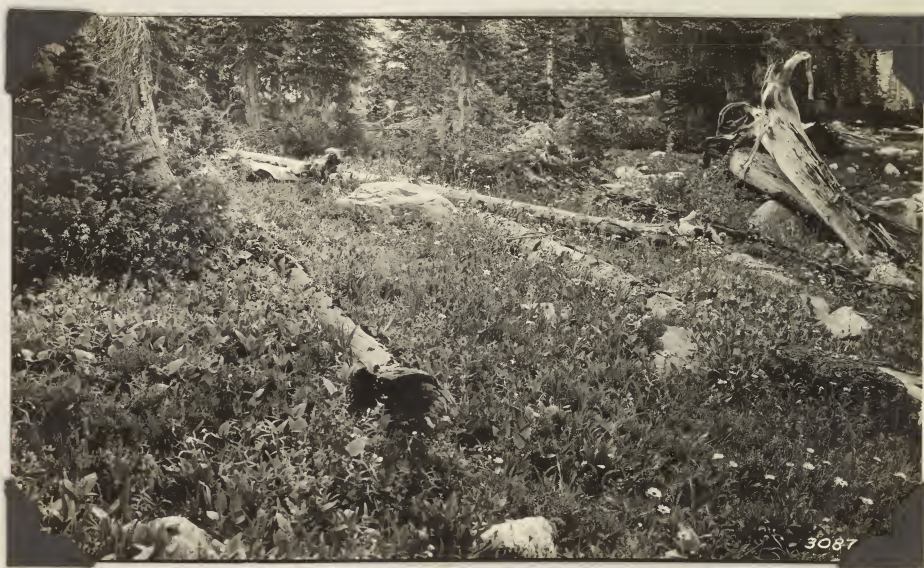
Uinta National Forest - Provo River Road

Detail of a natural forest cover, not as yet disturbed by any camp or picnic use. Note the patches of red paintbrush and yellow sneezeweed. When camp ground and picnic facilities are developed in such areas a special effort should be made to preserve these bits of forest landscape which are valuable assets.

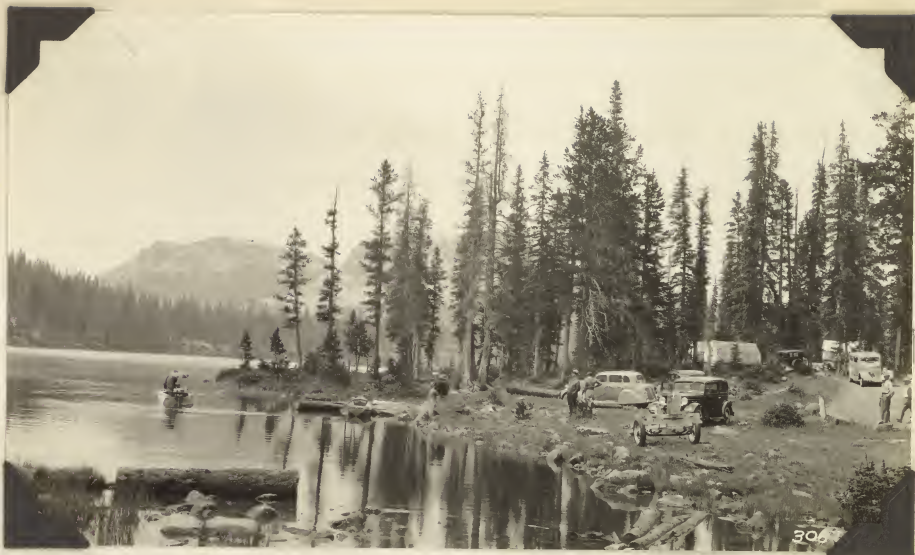
Uinta National Forest - Mirror Lake Forest Camp

General view taken from the entrance road and looking across the point of land extending into the lake. Note the interesting mountain peaks in the background. The use of this point of land for automobile traffic and for camp sites should be discontinued because of its natural scenic value.

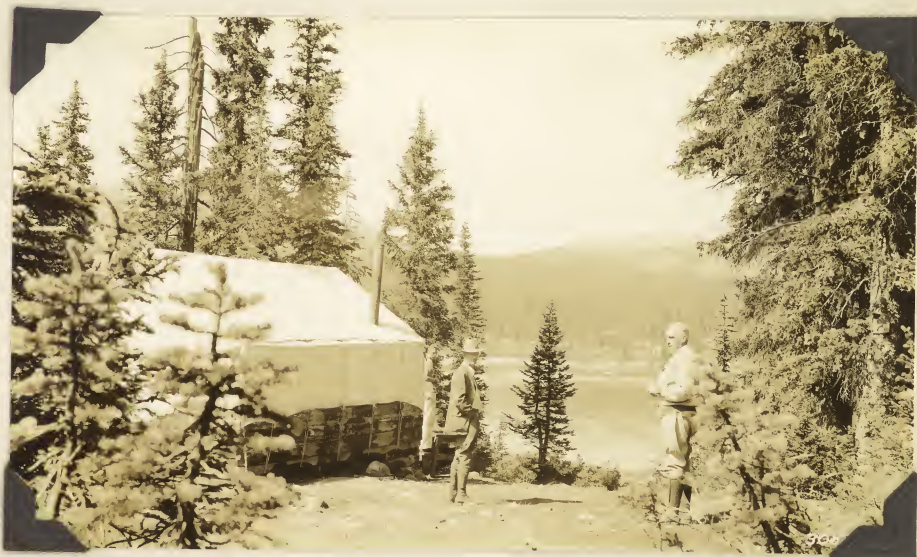
Uinta National Forest - Mirror Lake

General view looking over one of the camp units, which is placed in an unfortunate location because it interferes with the scenic view across the lake. It seems important that a re-study should be made regarding the proper location of camp units along the shore of this lake, in order not to intrude unnecessarily upon its natural beauty.

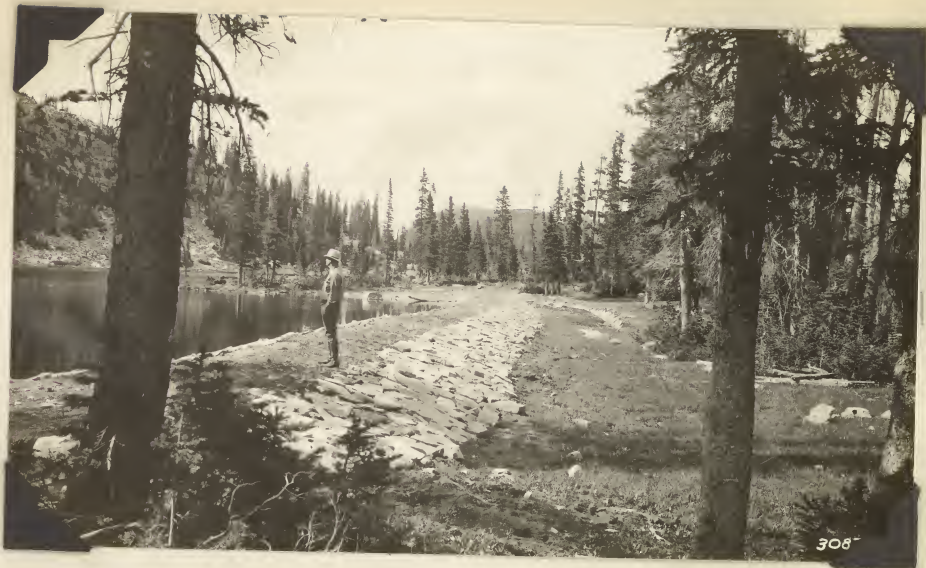
Uinta National Forest - along Provo River Road

Along the Provo River Road an artificial water area has been created by the construction of an earth dam (see photograph No. 308781, page 76), which is a very definite scar on the forest landscape. In general no earth dam should be constructed in any of the forest areas unless the design is most carefully studied so that the alignment of the dam and its general design will become a part of the natural landscape. The unattractive condition created by this earth dam should be corrected.

General view showing an earth dam of a type of construction which seriously detracts from the otherwise attractive and natural forest picture. Earth dams in such locations should be most carefully designed in order not to present a hard and unattractive note in an otherwise beautiful landscape.

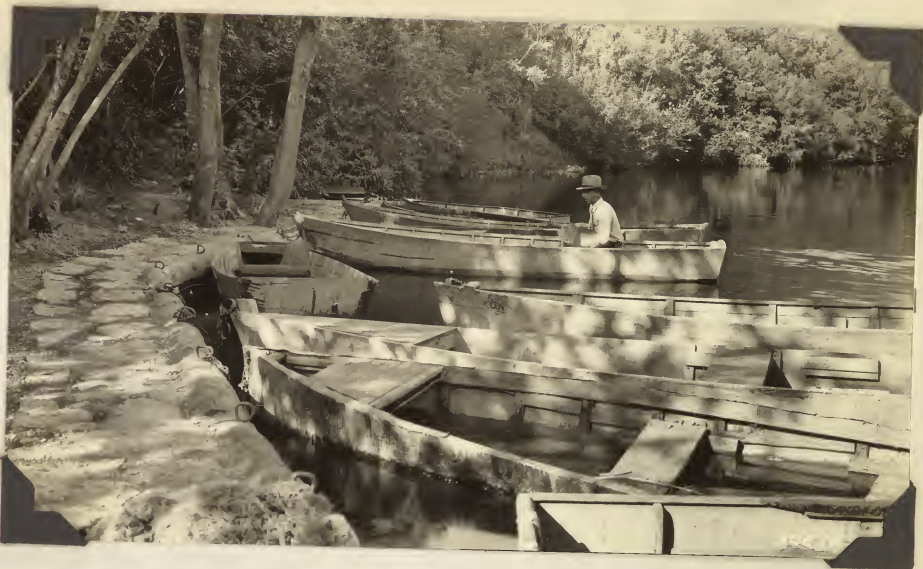
Cache National Forest - Spring Hollow Forest Camp and Logan Canyon

An interesting boat dock, made of logs and constructed parallel with the shore line. This type of dock is most appropriate and entirely satisfactory in this location, and could be used to excellent advantage in other locations.

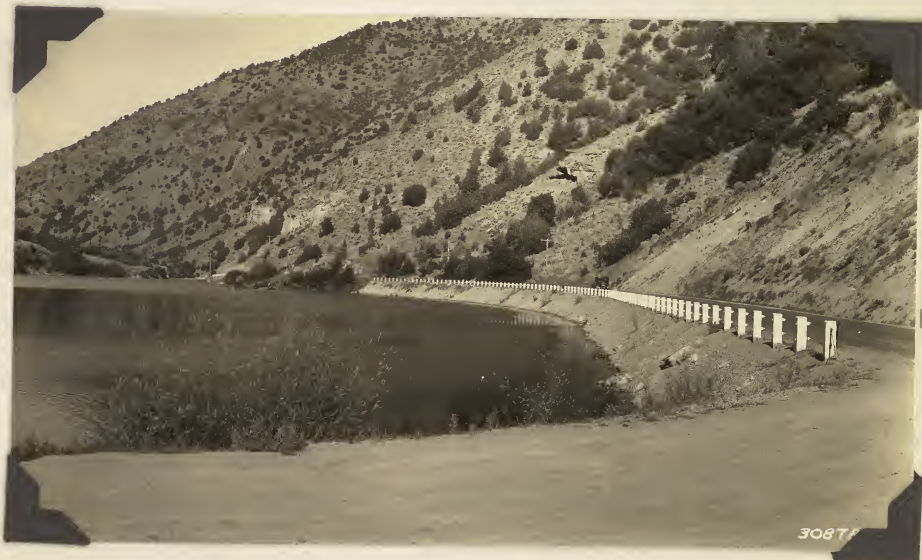
Cache National Forest - Logan Canyon

General view of the lake along the side of the highway, near the entrance to Spring Hollow Forest Camp. It is most desirable that the area between the highway and the margin of this artificial lake be appropriately planted with trees and shrubs to present an attractive and natural shore line.
